Testimony in Wood: Analysis of the Rail 16 evidence in the Lindbergh Kidnapping

Summary Report 1.2

Kelvin Keraga

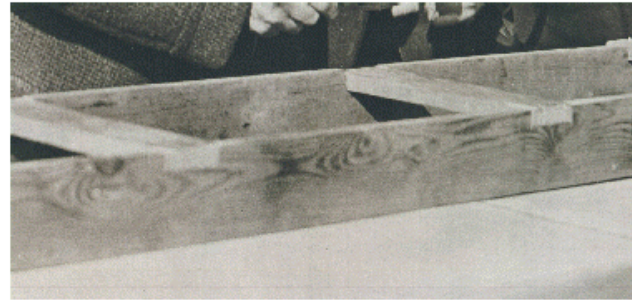
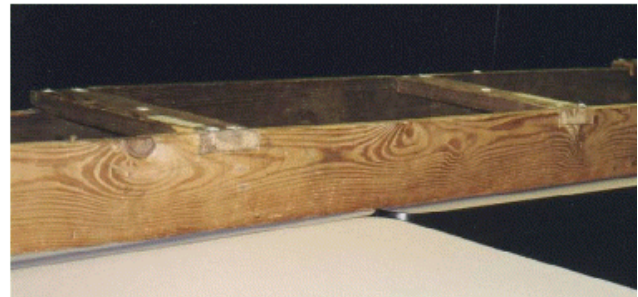
The author set up the current Rail 16 in the same position as the early photograph and created comparison images (Figure 4). An examination found very clear and unique match-ups in the knots and surface grain, establishing that the current Rail 16 is the same rail that was found on the ladder at the time of the kidnapping.

Figure 4: Comparison photos of Rail 16, pith side. Top: Detail from copy of Springfield photo, 3/2/32. Bottom: Photo of Rail 16 taken by author, 6/1/2001. Top photo courtesy of New Jersey State Police Museum.

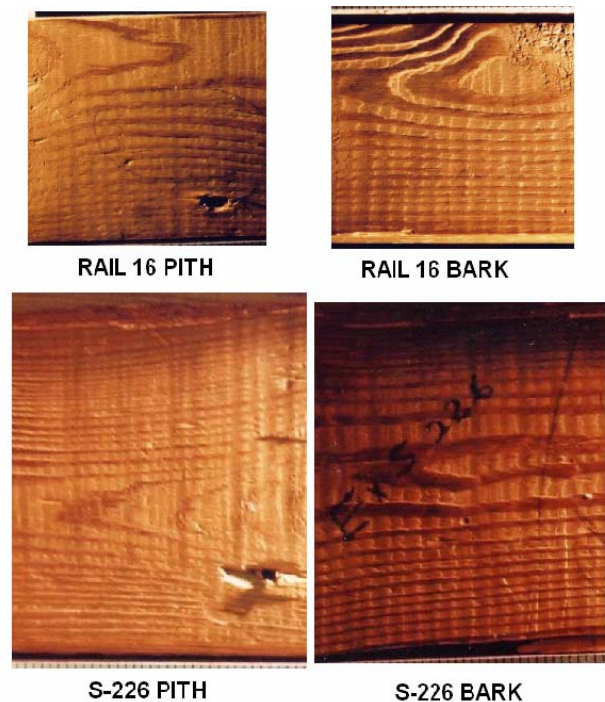
On sections of both boards, the knife marks are not evenly spaced, but occur in sequences of two close together. Both men identified that the coupling of the knife marks into sequences of two was a phenomenon known as "wavy dressing". Mr. Witham suggested that wavy dressing is sometimes created by a loose adjustment of the pressure bar, which holds the wood down: if the bar is loosely adjusted, it may allow the wood to vibrate, and cause wavy dressing. According to Mr. Price, wavy dressing is a fairly common characteristic of poorly-dressed lumber. On the evidence boards, however, these sequences tend to merge more in the same direction, toward the groove edge of S-226, and the comparable edge of Rail 16.

Figure 6: Periodic deep knife marks visible along the surfaces of Rail 16 and S-226.

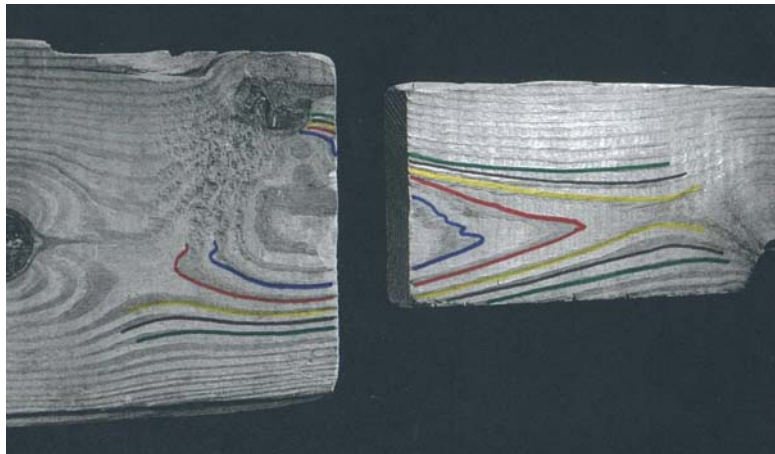
The author set the boards up vertically on blocks and clamps and compared the surface grain on both sides of the boards simultaneously (Figures 8 & 9). The alignment was based on a Forestry Department picture taken in the attic in 1934, showing the boards fixed in place with nails. Near the end of S-226 a large knot is visible, which distorts the rings in the areas closest to the groove edge. Away from the knot, however, the curves in the surface grain of the two boards were found to be in alignment across the gap: rings from specific years of growth on one board aligned with the same yearly rings on the other board. A plausible pattern, with a ring-for-ring match, existed on both sides of the boards, indicating that the relationship of the layers of tree growth was continuous throughout the boards. In addition, in examining the two boards the author also noted that both appear to have had a split in the cambium on the pith sides. This split is visible as a series of V's on both the sides and ends of the boards. When the boards are placed in the alleged attic position, the two grooves appear to follow a somewhat irregular but continuous curve around the knot on S-226 (Figure 9).

Figure 8: Comparing the bark (attic top) side surface grain of Rail 16 and S-226 in the alleged attic position. Rings have been color-coded on outer edge of latewood, which is the dividing line between annual rings.

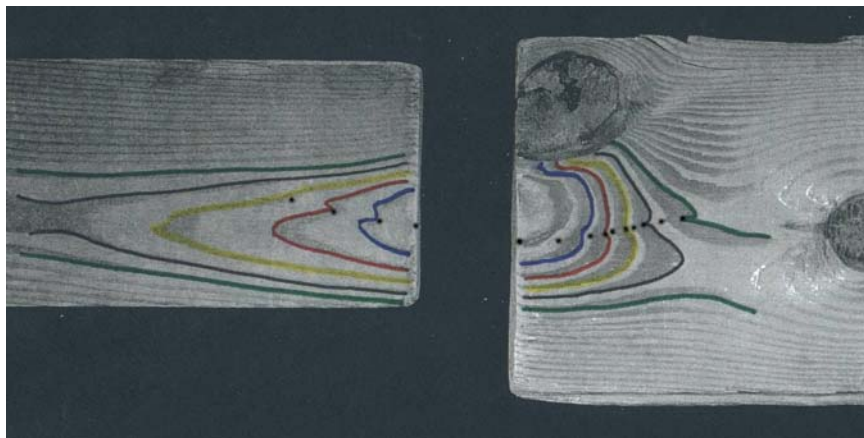
Figure 9: Comparing the pith side surface grain of Rail 16 (left) and S-226 in the alleged attic position. Photo taken with boards in same position as in Figure x. Rings have been color coded on the outside edge of the latewood, which is the dividing line between annual rings. In addition, the locations of the V-grooves on the surface and end grain have been plotted.

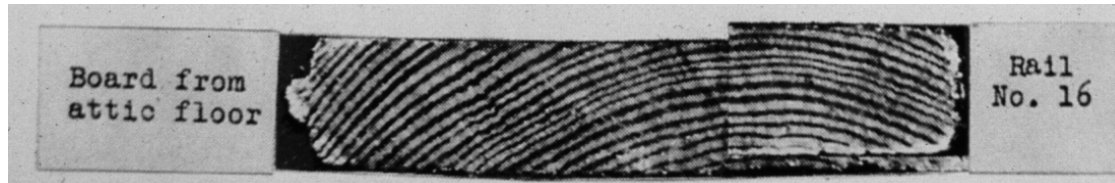
Figure 10: Koehler's photo of the end views. Photo courtesy of Forest Products Laboratory, Madison, Wisc.

the end view sequence is offset by two rings. This was found to be consistent with the surface grain, where two inner rings are visible on the bark side surface of S-226, at a swell near a knot at the end of the board, but are not visible on the surface of Rail 16²¹ (Figure 8). Therefore the offset of the rings that is visible in Koehler's demonstration photograph is not a discrepancy. In reality it displays consistency between the side surface grain and end grain patterns, and demonstrates that the combined ring patterns of the two boards create a plausible three-dimensional relationship.

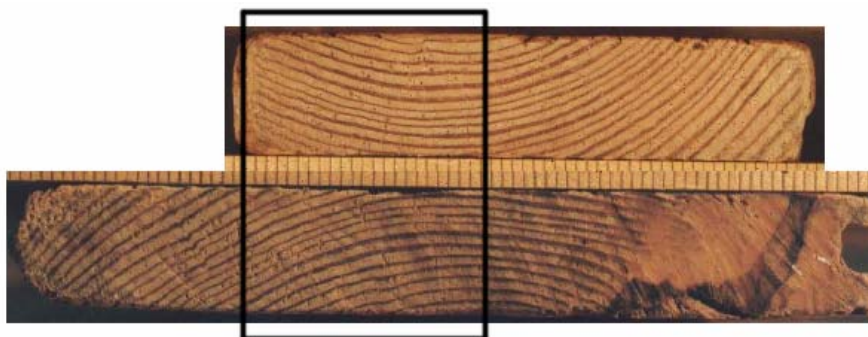
Rail 16 is narrower than S-226, and a knot at the end of S-226 distorts the grain near the groove edge, rendering comparison in that area meaningless. The author used the remaining section, an area about 1-5/16" wide was used. Since tree ring scientists typically work with a "core sampling" about 3/16" in diameter,²⁴ the 1-5/16" end view samplings of Rail 16 and S-226 were considered to be more than sufficient, and allowed for a wider range of comparison than typical core sampling. For this study, four avenues for comparison of the end views were explored: variations in thickness in the rings along the arcs; specific points of similarity; variation in the shape of the arcs; comparison of the thicknesses of the series of rings.

Figure 11: End views of Rail 16 and S-226, in alleged attic relationship. Rail 16 is on top. Rectangle indicates sampling area used by author for comparison (Figure 12). Note that Rail 16 has been stained with silver nitrate; consequently the color is lighter. Photos were taken with unfiltered tungsten lighting. Slight variation in scale.

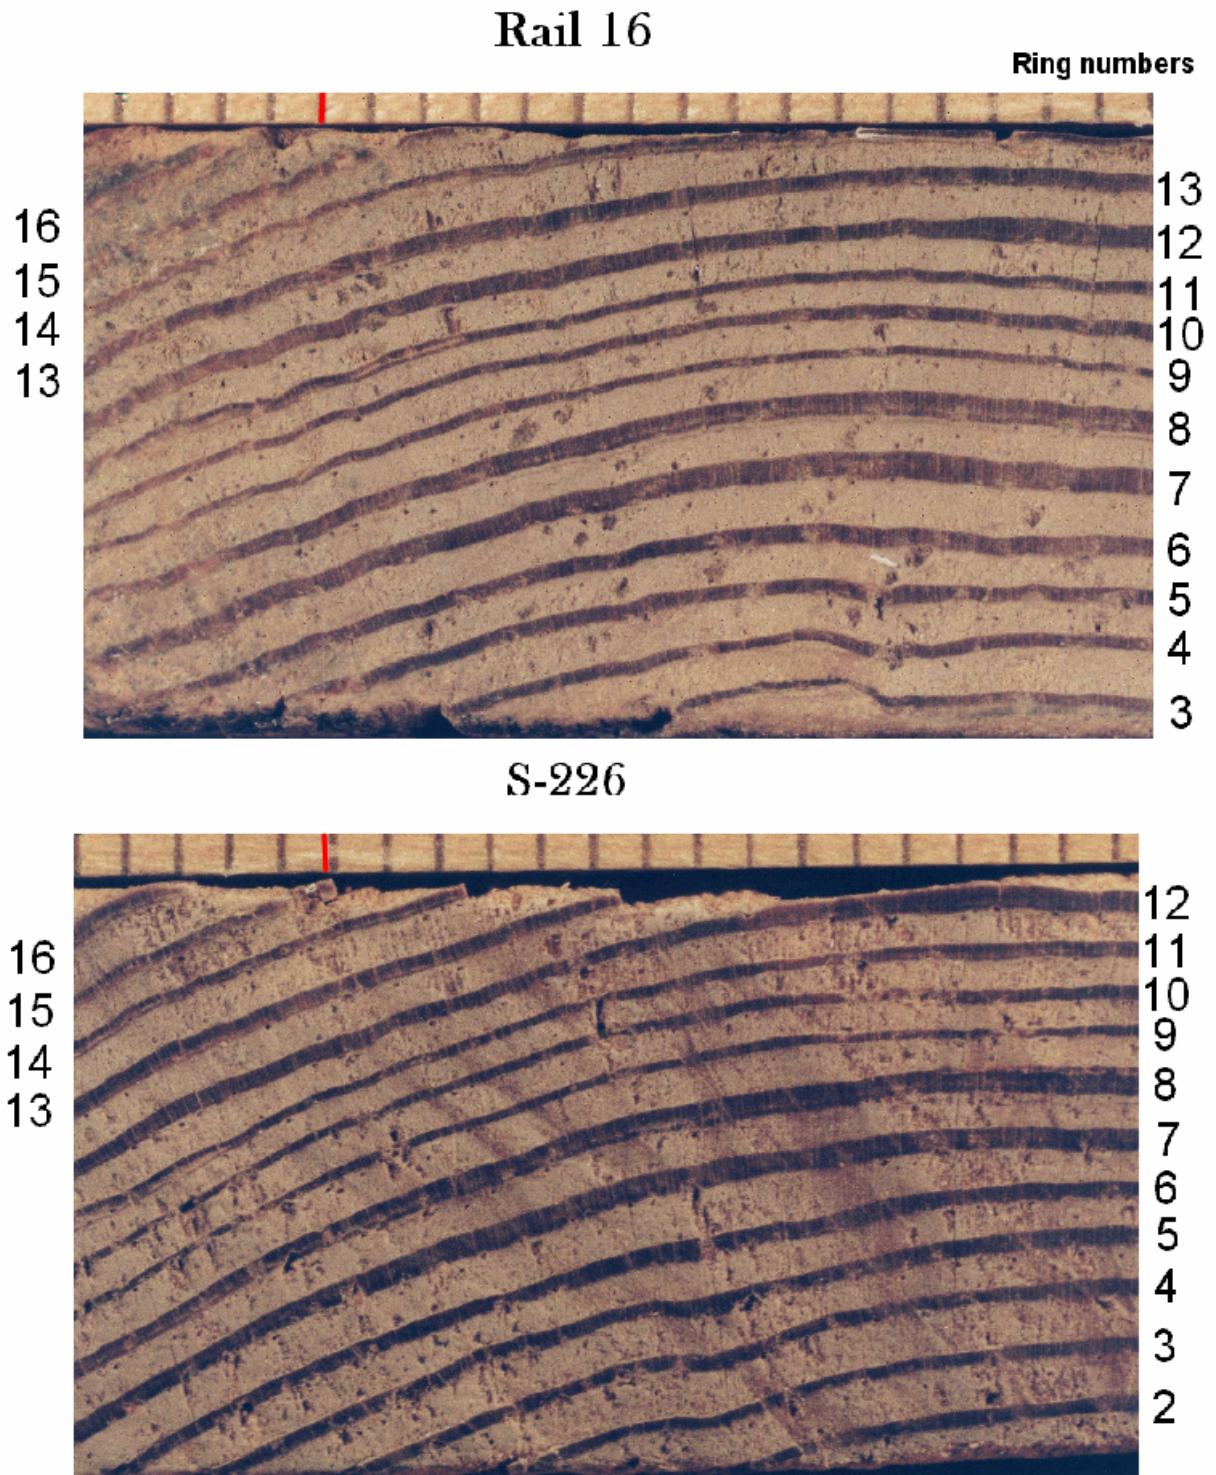
Variations in thickness in the rings along the arcs (see Figure 12): Tree rings often vary in thickness around the circumference of the tree, depending on grown patterns in each section of the tree. Both samplings revealed similar variations in ring thickness around the arcs. In both samplings, the latewood sections of rings #6, #7, #8, #10 and #11 were thicker at the tops of the arcs than farther down to the left. In the case of latewood ring #12, both boards exhibited the same variations: the ring was thick at the top of the arc, thinner to the right of the top of the arc, and then thicker again farther to the left.

Figure 12: Sample areas of Rail 16 (top) and S-226 (bottom). Image of Rail 16 has been reversed in order to show it in correct alignment with S-226. The spacing marks on the ruler visible in the photos are in 1/16" increments. The red marks on the rulers indicate the approximate alignment of the two pieces when the boards are in the alleged attic position. Rail 16 is slightly lighter due to staining with silver nitrate. Slight variations in scale may occur between both photos. Photos unretouched except for alignment marks.

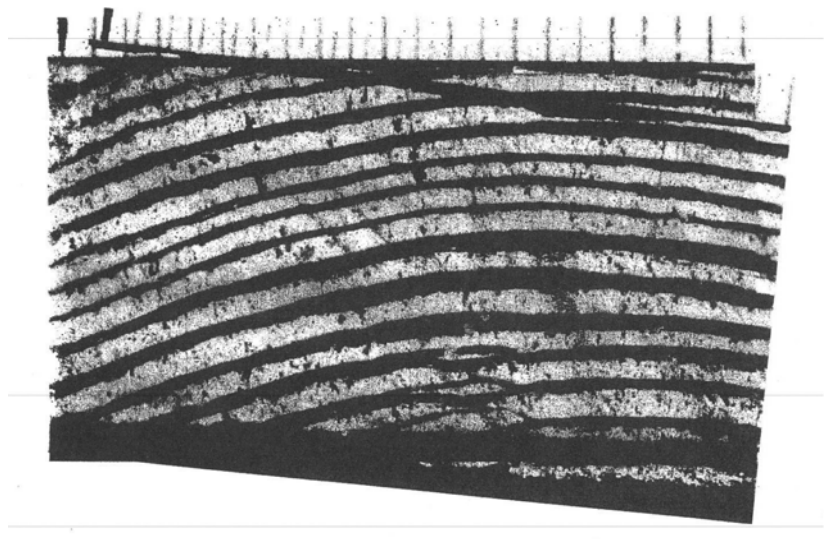
Figure 13: Overlay of transparencies of scaled, high contrast images of the sampling areas of Rail 16 and S-226. Photo by author.

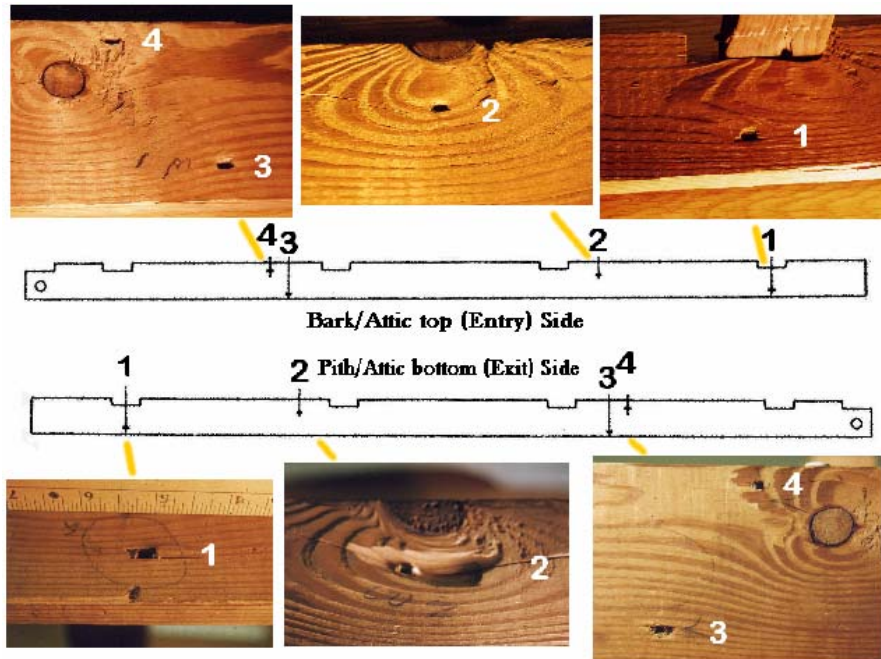
Figure 14: Left, Photographs and locations of the four nail holes currently in the face of Rail 16. Photos vary in scale. The diagram is adapted from a drawing by Arthur Koehler. The nail hole numbers have been assigned numbers by the author. Nail #2 chipped out a piece of wood on the exit side (bottom center). The small dark spot below nail hole #1 on the pith side is not a nail hole but a small area of compressed wood along the edge. Nail hole #1 was identified and circled by Dr. Erastus Meade Hudson during the trial. His small "H" is visible in the upper left. Below, cut nails from Hauptmann's attic.

- New York Daily News, March 5, 1932 (not shown⁴⁰). This photograph appeared in the Daily News on March 6, 1932. The original was found in the New York Daily News Archives. In this photo, nail hole #1 is visible. This is the one nail hole recognized by Dr. Hudson during the trial. Hudson's nail hole can be identified as #1 because he circled and initialed it during the trial⁴¹. The circle and initial are still visible on the board today (Figure 14).

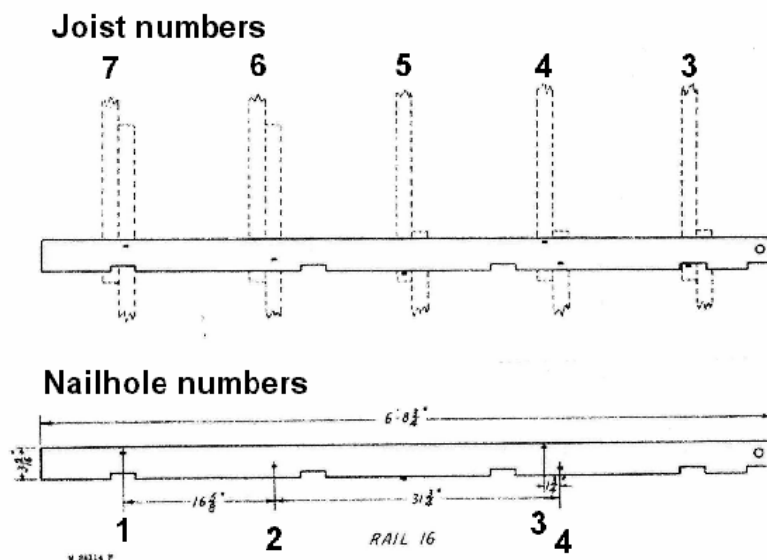
The four pre-existing nail holes in Rail 16 are not spaced at even intervals (Figure 19). Three of them are close to 16 inches apart, a fairly common spacing in construction, since wall studs and floor joists are frequently spaced at 16" intervals. However, the fourth (nail hole #3) is offset, and only matches Hauptmann's attic because the joists are spliced in this location. The pattern of the pre-existing nail holes in Rail 16, then, is consistent with the notion that Rail 16 was part of a toe board, face nailed into spliced joists in Hauptmann's attic. The pattern also indicates that one of the only locations where Rail 16 could be planted into an attic floor would be in a situation where the suspect has a face-nailed board at the location of a splice in the joists. According to Bronx insulation workers interviewed by the author, this is a rare occurrence.⁵⁰

Figure 19: A diagram by Arthur Koehler. (Numbers added to diagram by author.)

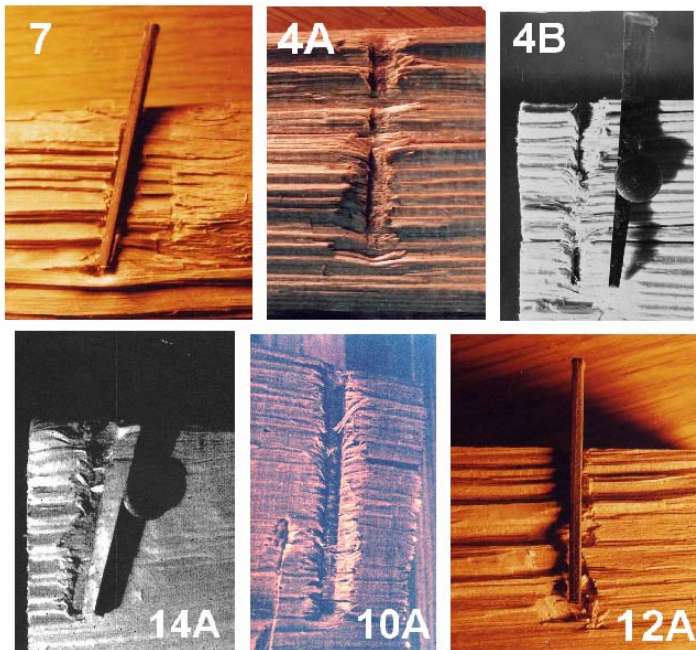
Figure 20: Nail channels in the attic joists. Joist numbers are shown. The joists were numbered from west to east in the attic, which would be right to left in Figure 26. “A” is the left (East) joist, “B” is the right (West). The top three joists correspond to Rail 16 Nail holes #1 (Joist 7), #3 (Joist 4A) and #4 (Joist 4B). The bottom three joists correspond to nail holes in S-226.

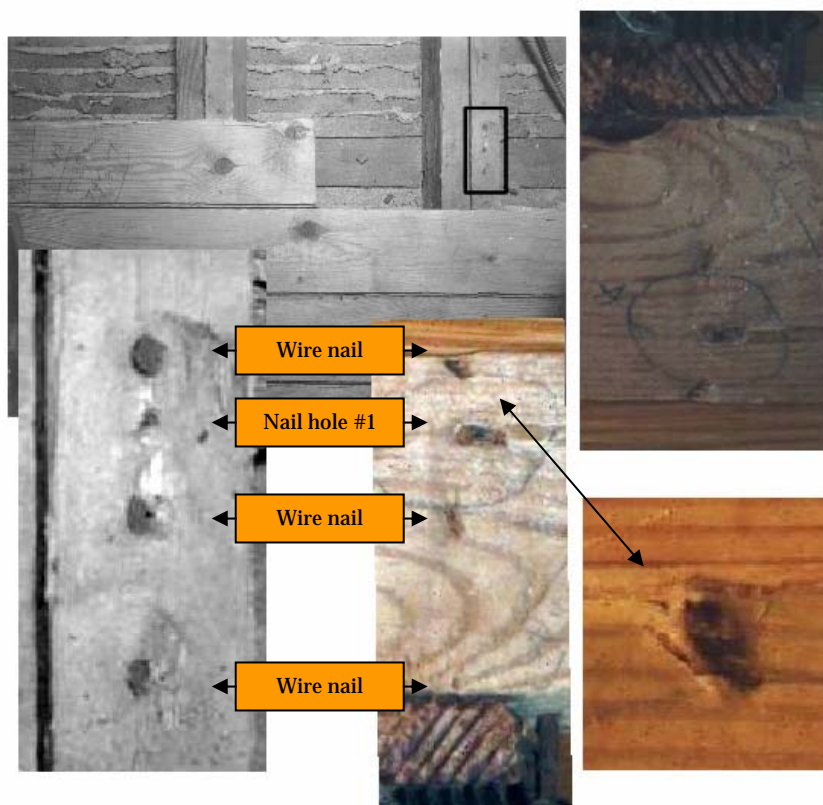
The appropriate section of Rail 16 was examined for marks from these nail heads. Impressions were found on the surface of the rail in the areas that correspond to the nail heads (Figure 21). At the location of the southern-most nail head (top in photos) Rail 16 was found to have an area of compressed wood with a semicircular imprint, which corresponds in shape and location to the protruding eastern edge of the southern-most nail. Since the police set the rail on top of these nail heads during their investigation in 1934, imprints could have been created at that time. Significantly, however, the imprint of compressed wood on the edge of Rail 16, corresponding to this southern-most nail head, is visible on the New York Daily News photograph taken on March 5, 1932.⁵⁶

Figure 21: Nail head impressions in Rail 16.

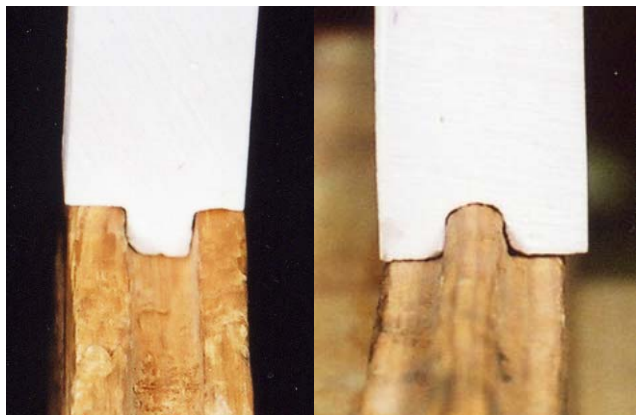
Board A-2 was used by the author to create molds of its tongue and groove profiles, which were then inserted into the grooves and over the tongues of the other boards. The molds were found to fit the profiles of the other boards (Figure 23).

Figure 23: Molds created from Board A inserted over S-226 (left) and S-226 extension (right).

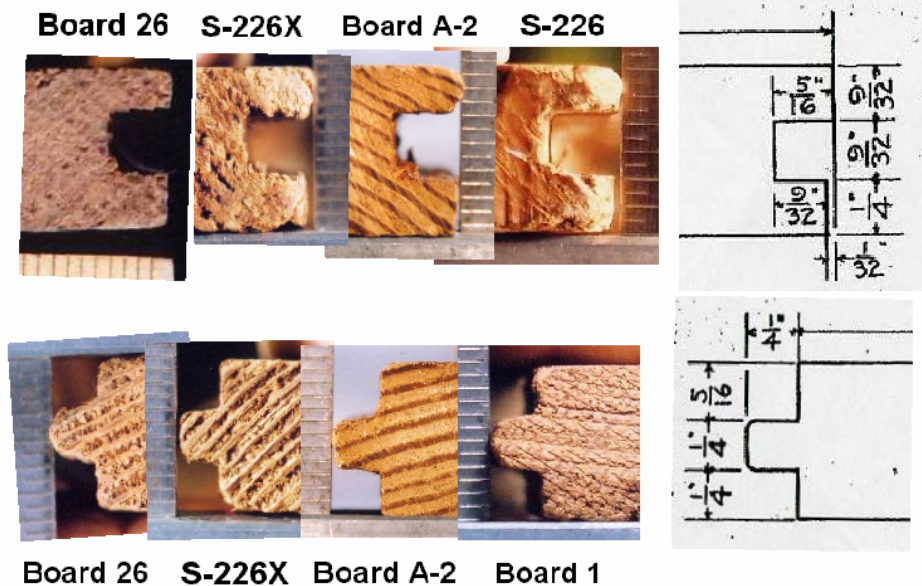
1. The longer groove wall was thinner, rather than thicker, than the shorter groove wall.
2. Specifications typically call for the lower groove wall to be of the same thickness as the space below the tongue. This creates a strong fit, as the lower groove wall is set under the tongue of the board before it. In the case of Boards S-226, 26 and A, however, the groove wall was thicker than the space below the tongue. According to Hendal Price, this variation is called a "mismatch".
3. The lower corner of the groove was somewhat rounded, and there is tear-out along the grooves in this area due to damage or irregularities in the groove-cutting knives (Figure 24).

Figure 24: Tongue and groove profiles, of the boards. These corners are often damaged; S-226 is badly deteriorated at the tongue corners and so was not included here. Molds used on inner sections of the edges (Figure 23) provided more accurate comparison. The tongues and grooves are compared here with specifications from the “1926 Official Inspection Rules of the North Carolina Pine Association, Inc.” This guide was used in mills in Virginia, Maryland and the Carolinas. The guide illustrates two specification details still in use on standard match patterns today: (1) the longer (upper) groove wall is also thicker; (2) the shorter (lower) groove wall is the same thickness as the space below the tongue. See text for details.

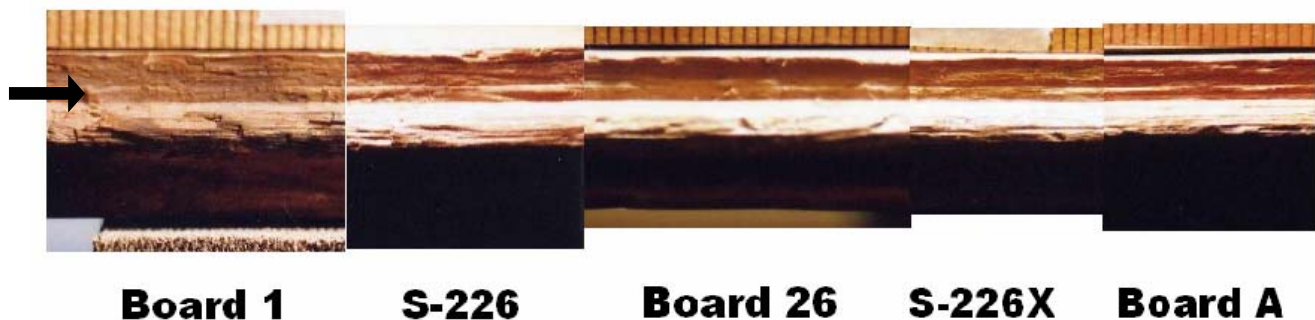
In addition, all of the boards, including Board 1, have the same planer defect along the tongue edge: a thin, scratch-like groove on the pattern underside close to the tongue (Figure 25).

Figure 25: Thin groove-like defect on tongue edge. In this photo, the pattern-bottom side is up, and the groove is visible just above the tongue. Photos to scale.

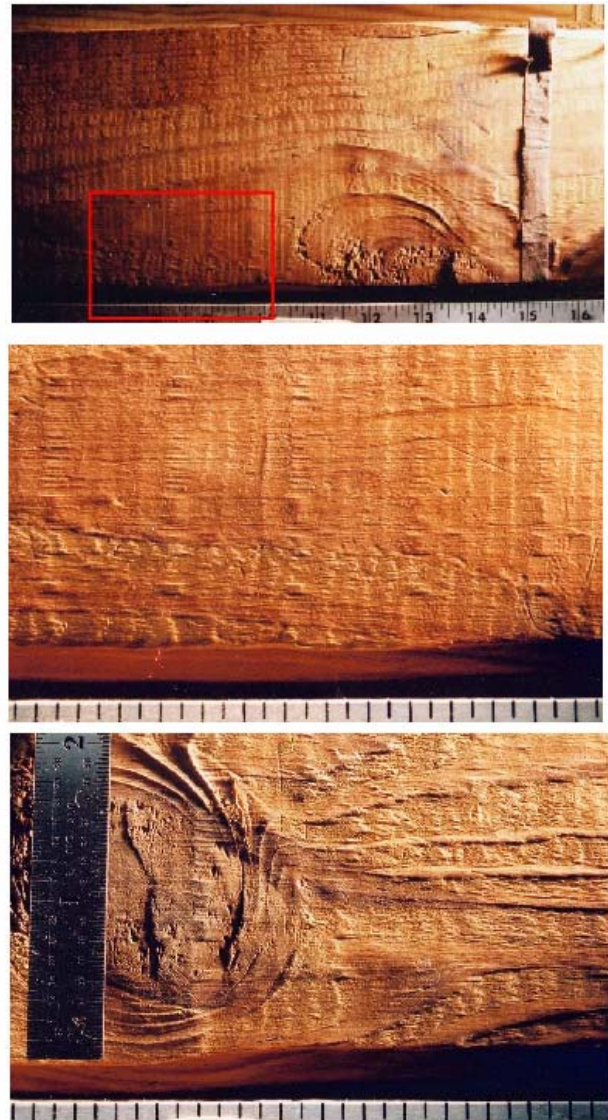
An inspection of S-226 and Board A found remnants of defects that matched the characteristics of those on Board 26. Vague similarities were also found in the appropriate location on Board 1, but the condition of the planer marks was poor.

Figure 26: Planer defects on Board 26. Top: Section of Board 26 photographed in oblique lighting, with defect area highlighted. Middle: close-up of defect area from top photo. Bottom: Close-up of another section of Board 26. Note how defect is visible in knot area, but obscured nearby. In all photos planing went from left to right (down-tree to up-tree). Tongue edge at bottom.

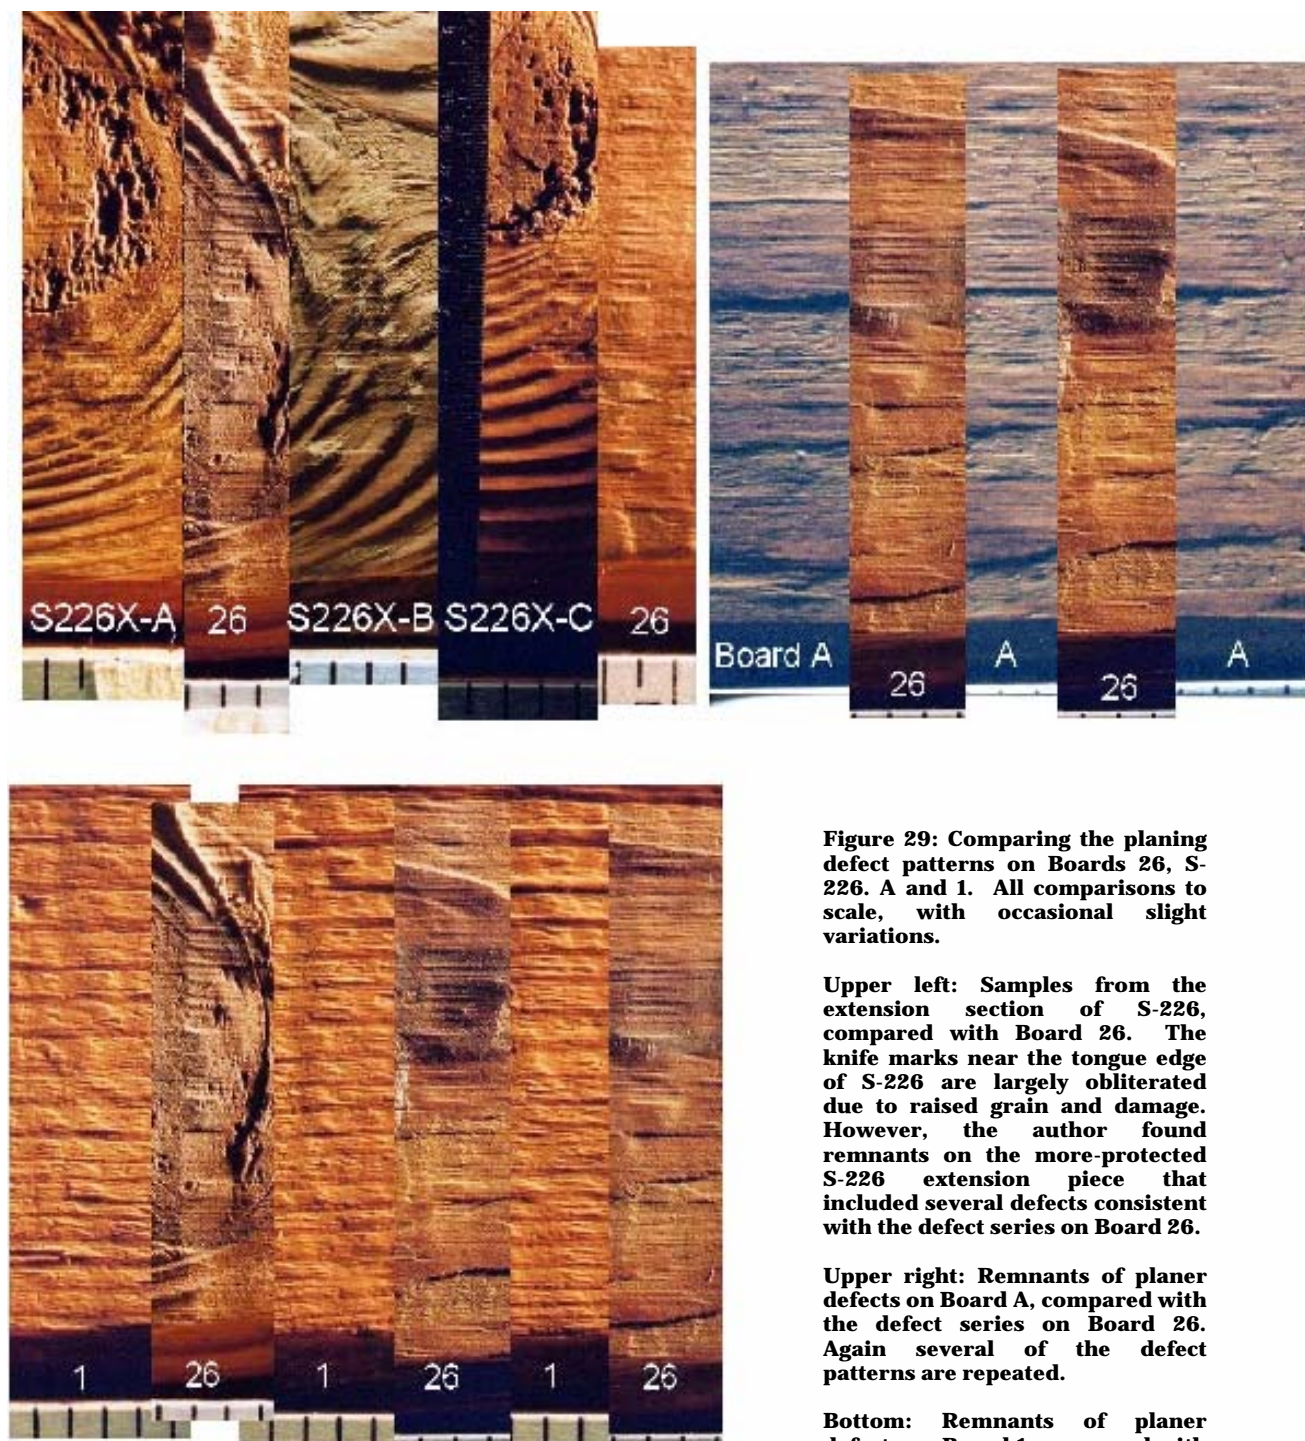
Figure 29: Comparing the planing defect patterns on Boards 26, S-226, A and 1. All comparisons to scale, with occasional slight variations.

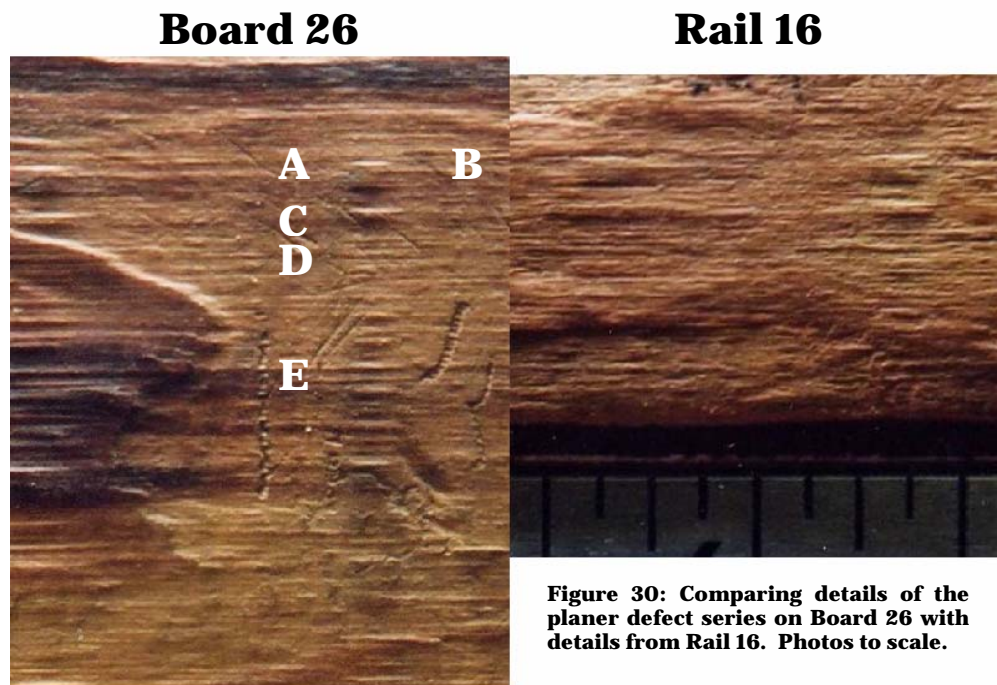
Figure 30: Comparing details of the planer defect series on Board 26 with details from Rail 16. Photos to scale.

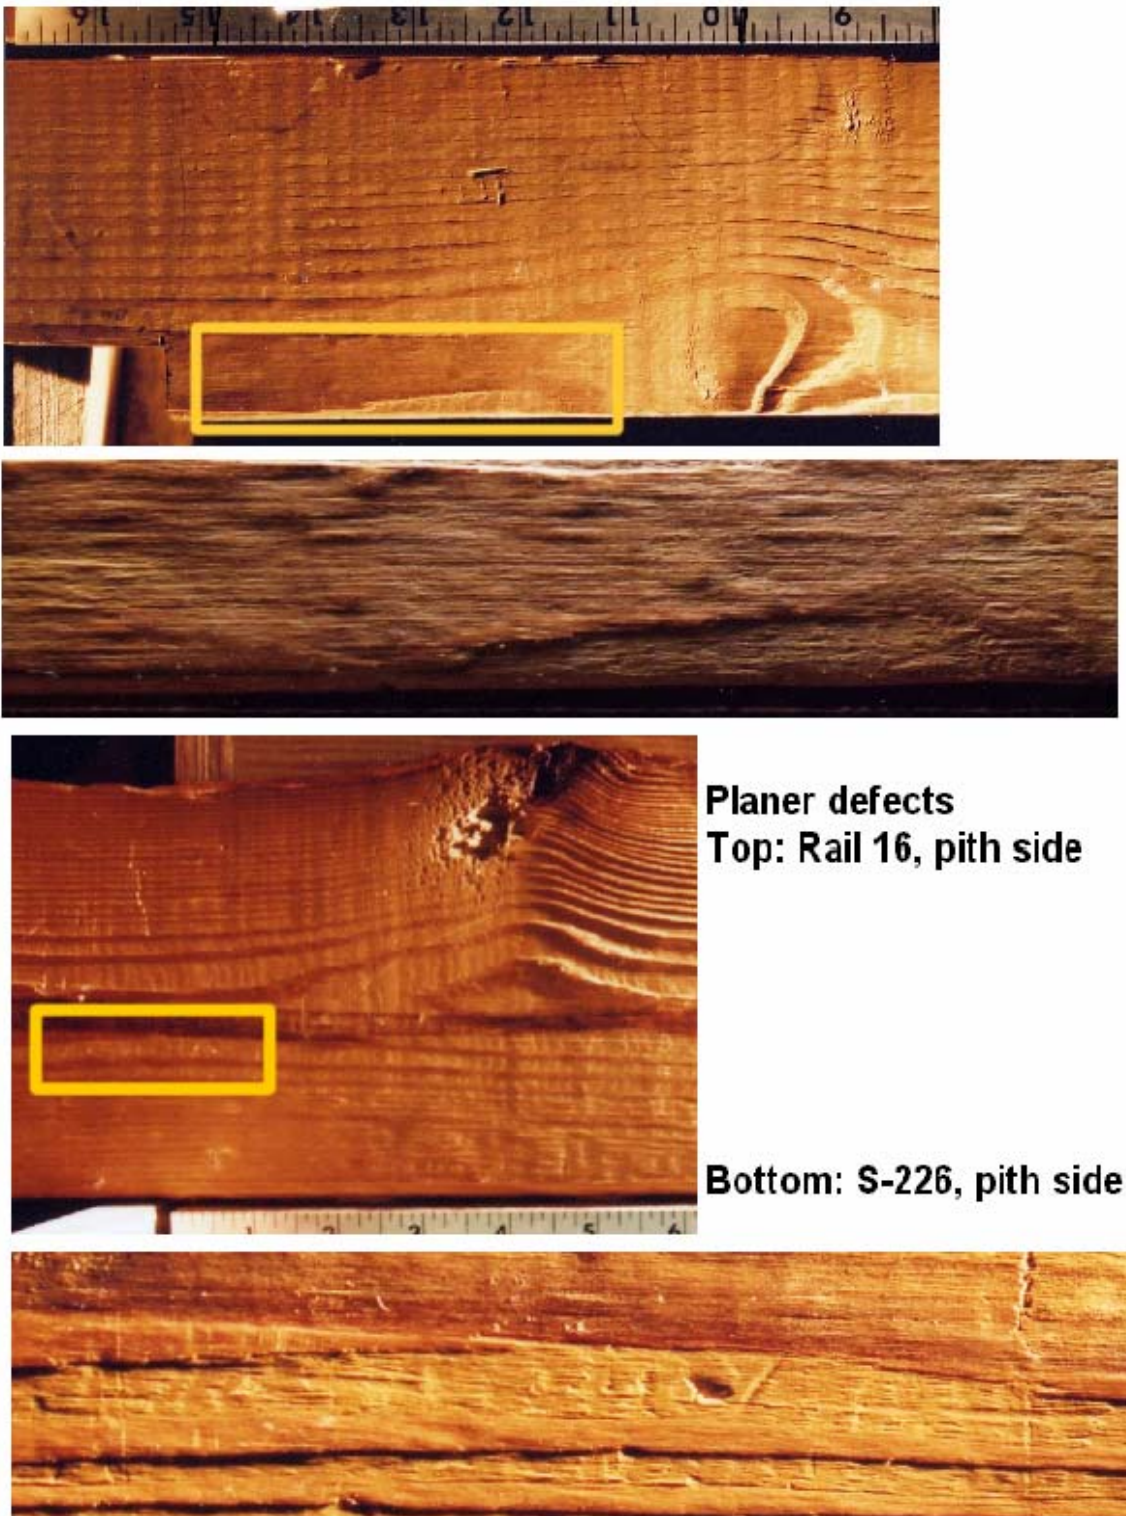
Figure 31: Sequences of planer defects on the pith sides of Rail 16 and S-226. Variations in scale.

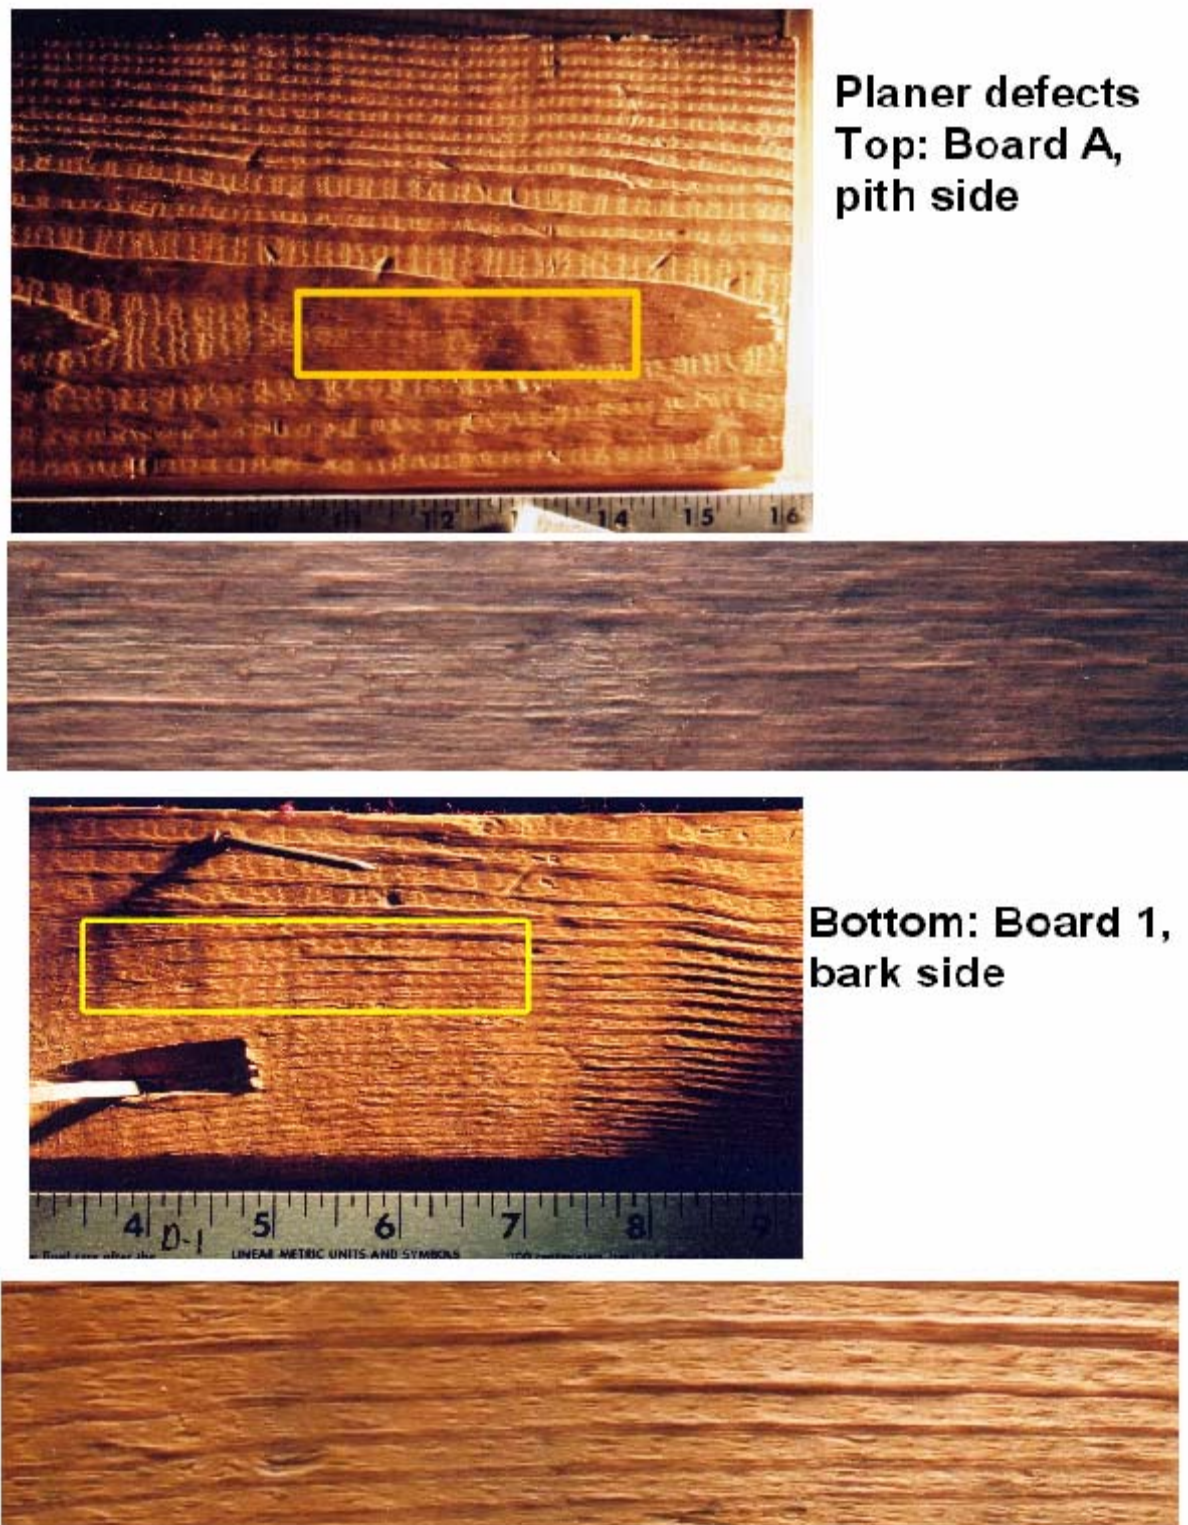
Figure 32: Sequences of planer defects on Board A and vague remnants on Board 1. Variations in scale.

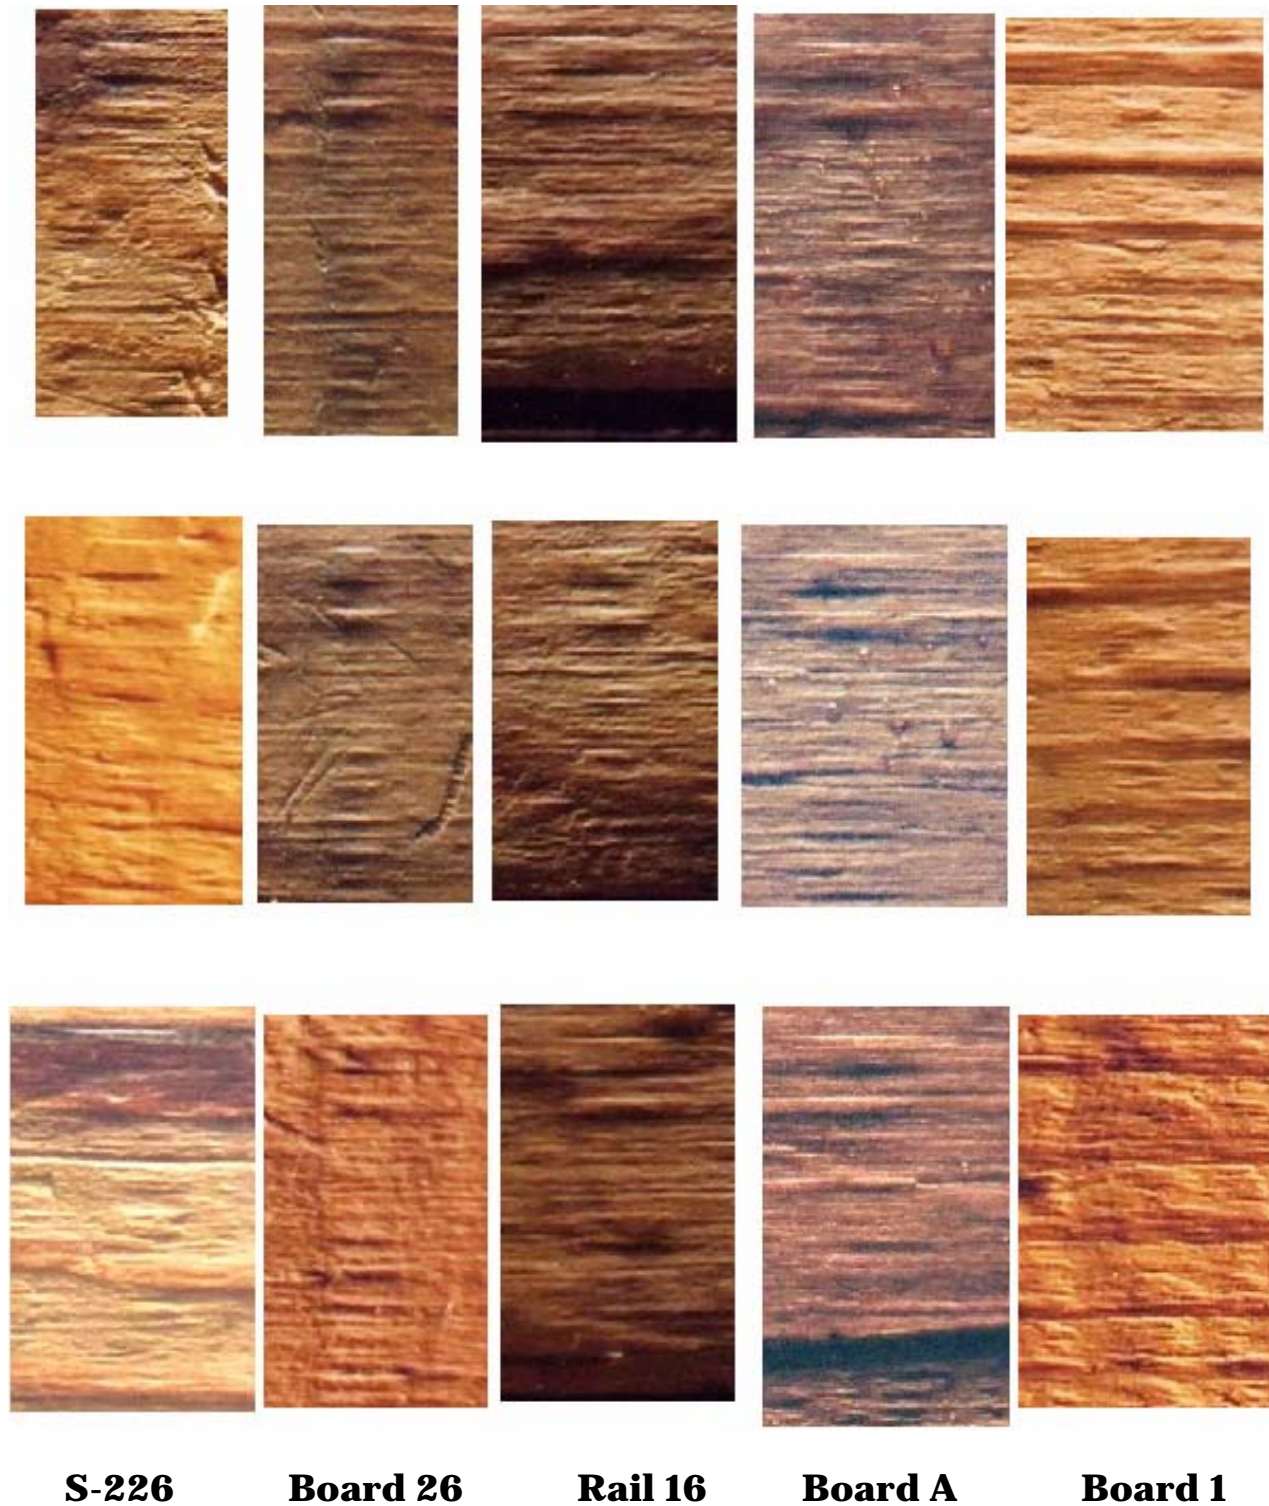
Figure 33: Samples of some of the clearest examples of the inner defect series on the boards. The boards vary in condition and shrinkage. Board 1 has the most deterioration, and Board s-226 appears worn, with little detail in this area. The photos vary in lighting and quality. While the author was careful to adjust all of the images to the same scale, some slight variations may occur.
