Testimony in Wood: Analysis of the Rail 16 evidence in the Lindbergh Kidnapping

Summary Report 1.2

Kelvin Keraga

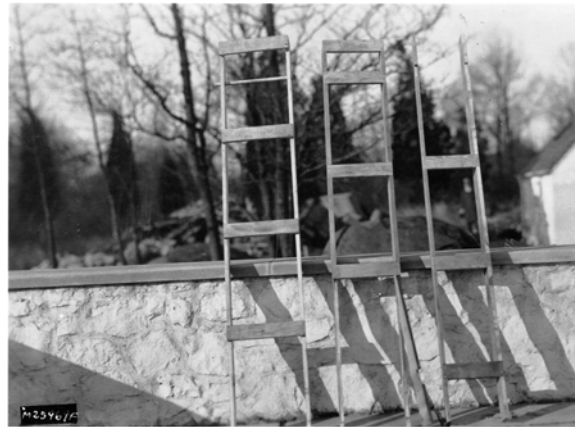
Figure 1: The kidnapping ladder. Rail 16 is the upright on the far right. Photo courtesy Forest Products Laboratory, Madison, Wisc.

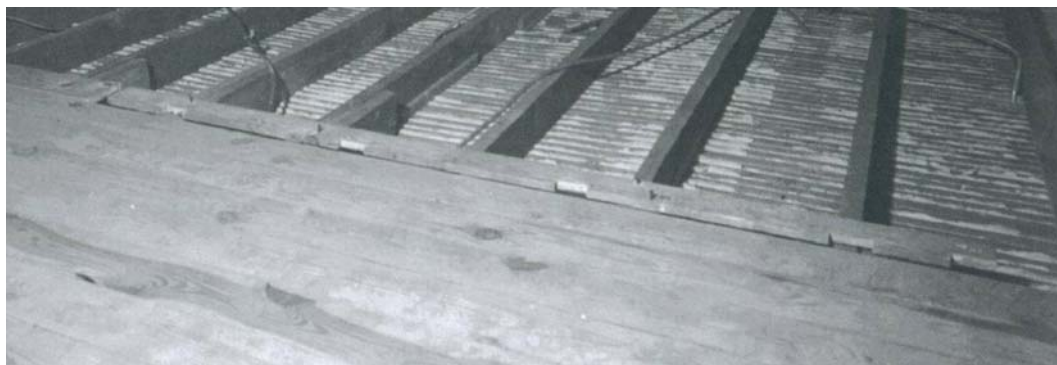
Figure 2: Rail 16 in the attic. The tip of S-226 is visible on the far left. Photo courtesy New Jersey State Police Museum, W. Trenton.

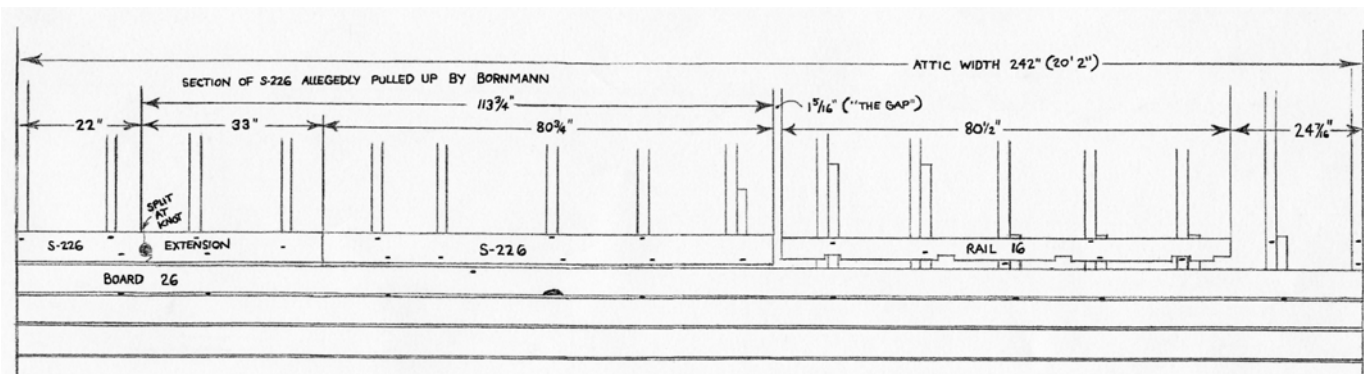
Figure 3: Author's diagram of the arrangement of boards in the attic. Attic floor continues at bottom, with "Board 26." "S-226" was the evidence number for the section of attic board (center) used in the trial. In the text, the two extension pieces of S-226 (far left) are referred to as "S-226X."

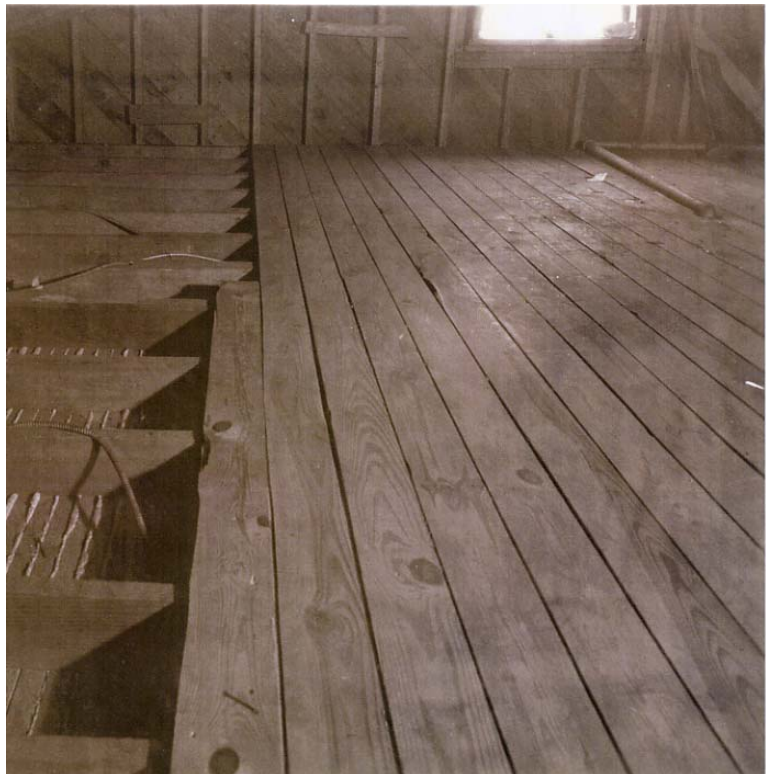
Figure 16: Hauptmann's attic. S-226 is in the foreground on the left. Rail 16 is not installed; it would go above S-226 in the picture. Grooves edges of the boards are towards the left side of the photo. Boards appear to be uncut along their entire lengths. Photo courtesy New Jersey State Police Museum.

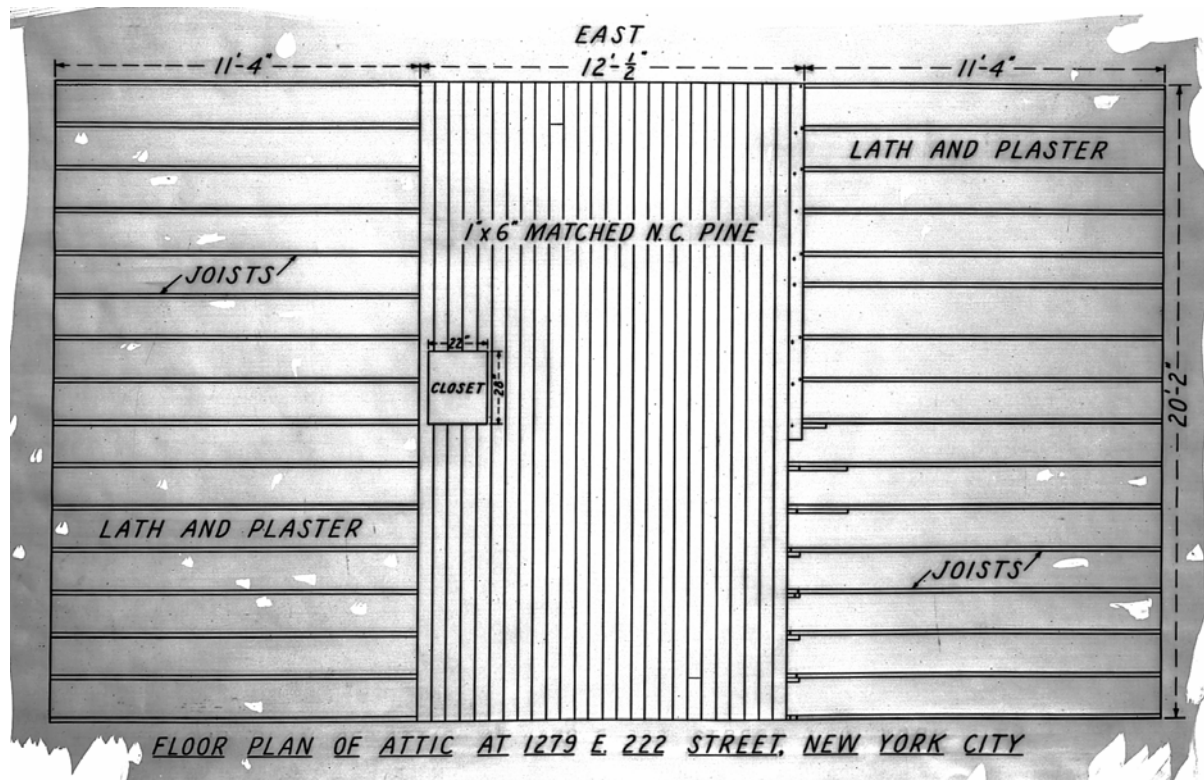
Figure 18: Koehler's diagram of Hauptmann's attic. S-226 is the partial board on the right. Rail 16 is not shown. Photo courtesy Forest Products Laboratory.

Investigators for Governor Hoffman pointed out that Koehler's attic diagram includes an error: the attic is much closer to symmetrical when Rail 16/S-226 not included.⁵¹ This has led to speculation that the attic originally only had 26 boards. However, Board 26—the next board over from Rail 16—has been preserved at the archives of the New Jersey State Police, and the author was able to examine the nailing pattern of this board. There were only nine nail holes along the entire length of the board; eight of them are in the shoulder of the tongue (see Figure 3). There were no nail holes at the ends of the board: at one end the closest nail hole was 15-1/2" from the end; and on the other, the closest nail was 18-3/4" from the end. There were no nail holes along the groove edge, except one face nail, which was a little over an inch from the groove edge in an area where there was a bump in the wood. According to Greico, a carpenter would put nails at the ends and along both edges of a toe board. Overall, he thought that the nailing pattern of Board 26 was that of an inner board. The nailing pattern of Board 26, then, does not support the hypothesis that it was a toe board in a 26-board attic.

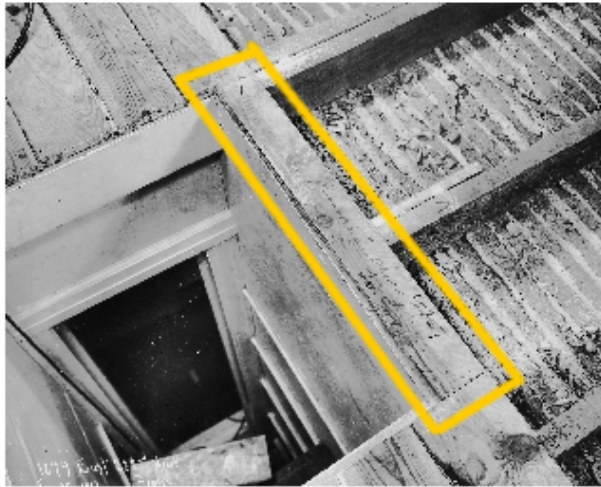
Board 1

Board 1: A small piece of this board, about 27" long, was removed from the attic by Leon Hoage in 1937.⁵⁸ This piece came from the opposite side of the floor from Rail 16. It had been located at the edge of the attic hatch and had been narrowed for the opening; a couple of inches of width, including the groove edge, were removed.

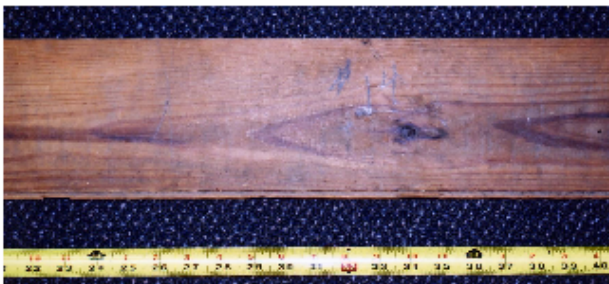
Board 26

Board 26: Hoage also removed the entire length of Board 26, the next board over from the alleged attic position of Rail 16/S-226.

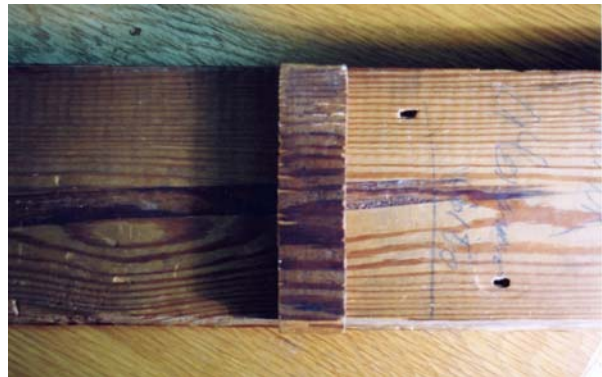
Width: The boards all have one groove wall slightly longer than the others. The widths of the boards⁶⁰ were measured, from the tongue edge to the end of the longer groove wall. S-226 and Board A-2⁶¹ were virtually identical in average thickness (5.13" and 5.15" respectively; Figure 22) and Board 26 was slightly narrower (5.09").

Figure 22: Board A-2 on top of S-226.

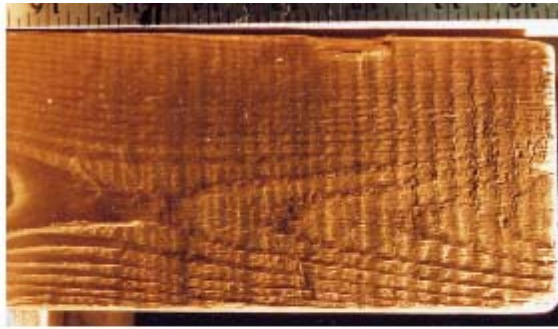
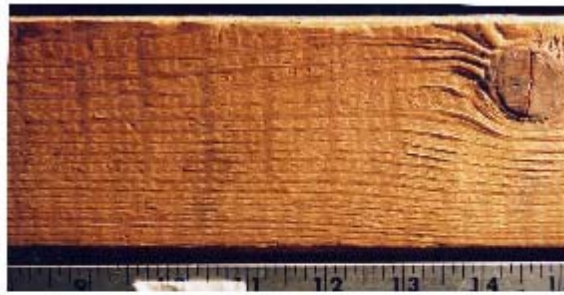
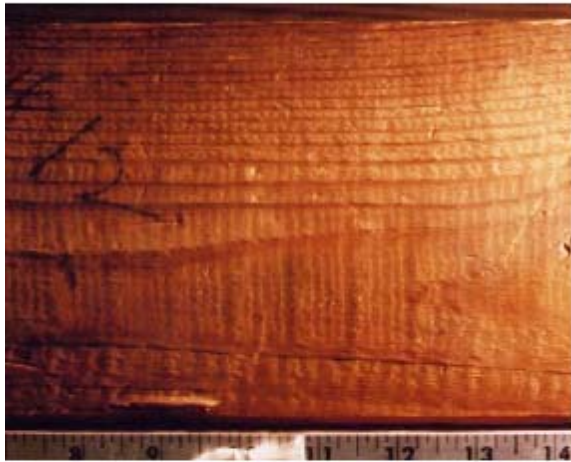
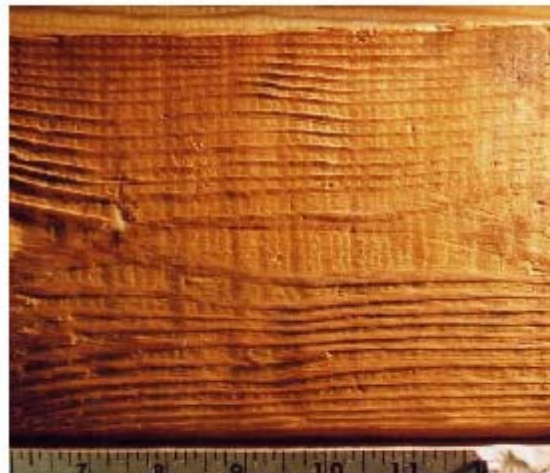
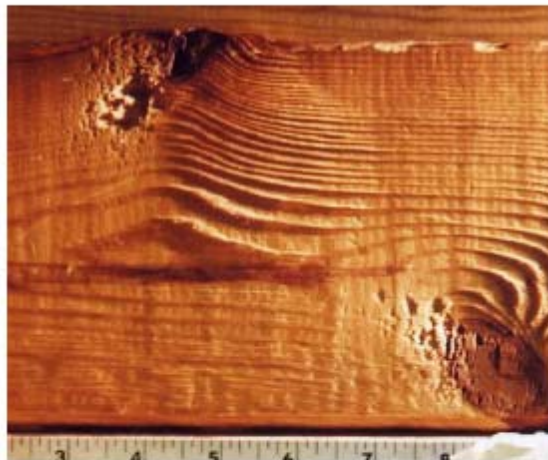
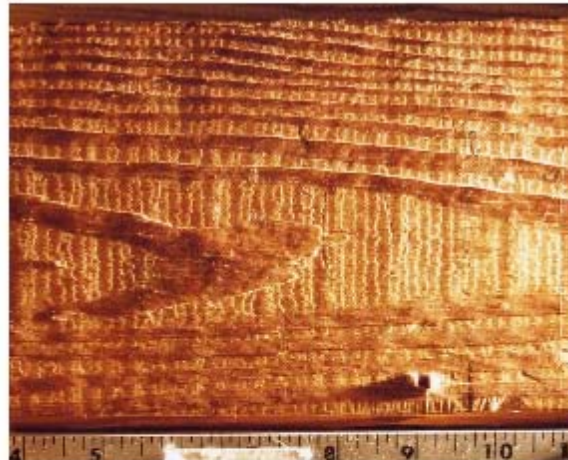
Inspection of the boards found that Boards 1, 26 and A had the same general planing characteristics as Rail 16 and S-226. All of the boards were found to have eight knife marks per inch, with occasional irregularities. As in the case of Rail 16 and S-226, side-lighting of the other boards revealed sequences on both sides in which every sixth knife mark was visibly wider (Figures 27 & 28). The pattern is most visible in areas with little or no wavy dressing. This pattern indicates that all of these boards were dressed on a planer with six knives on both the top and the bottom cylinders. On both sides, one of the knives was offset from the others, and so created the wider groove. All of the boards with knots had significant torn grain in close proximity to knot areas, suggesting that all of these boards were milled at a point when they had high moisture content. Board A does not have any knots, but has some moderate torn grain in the vicinity of surface grain curves near the end of Board A-1. All of the boards have areas of significant raised grain, and areas of wavy dressing.

In the areas of the sides of the boards close to the edges, where there are a large number of rings, the raised grain and wavy dressing often distort or obliterate the planing marks. Upon inspection, however, the author noted a consistent irregularity on the under-pattern side of the boards (visible on some of the boards towards the bottom in Figure 27). Close inspection revealed this to be a pattern of planer defects, in the form of grooves and ridges, extending approximately 1-5/8 to 1-3/4” in from the tongue edge. (The width of the boards, and of the defect pattern, varies slightly due to board irregularities and shrinkage.) This defect series was most clearly visible on Board 26, which appeared to have come from a somewhat crooked tree; because of this irregularity, some sections of Board 26 that are close to the tongue edge have very few rings, and hence little raised grain. The defect series consisted of a pattern of grooves and ridges on the pith side of the board. The defects are not visible along the entire length of Board 26, as they are often obliterated by raised grain, damage and other factors (Figure 26).

Figure 27: Planing details on the pattern-bottom sides of the boards. The photos are presented to scale, but slight variations may occur. Planing from left to right. Tongue edges down. The photos vary in lighting, condition of the boards and quality of the images.

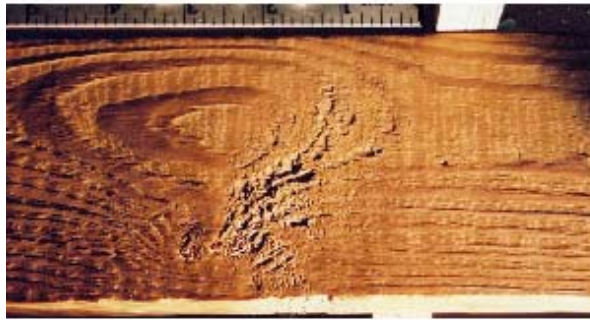
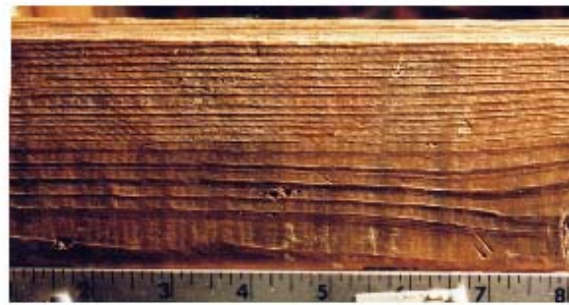
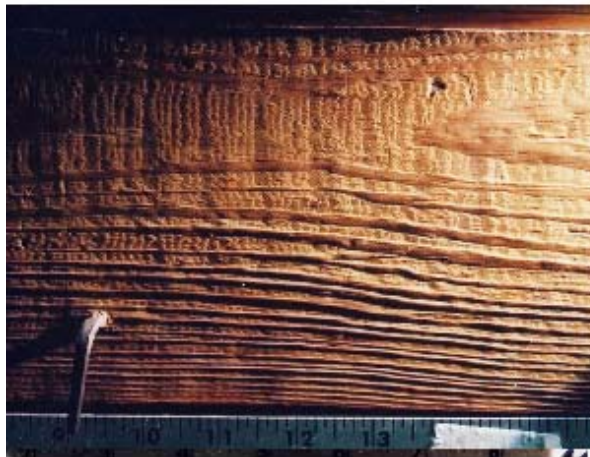
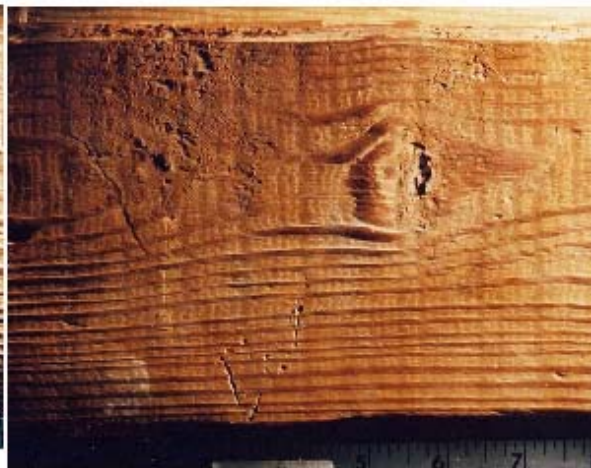
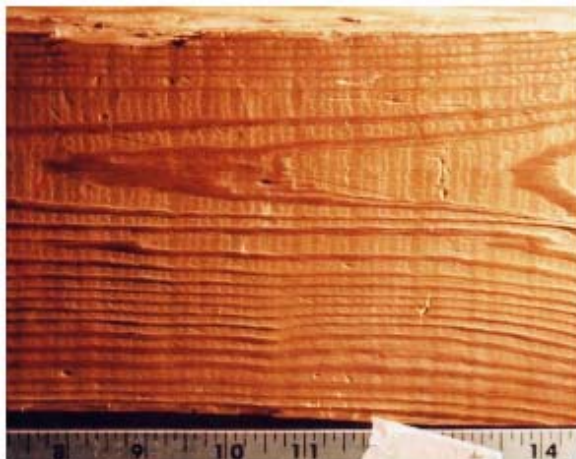
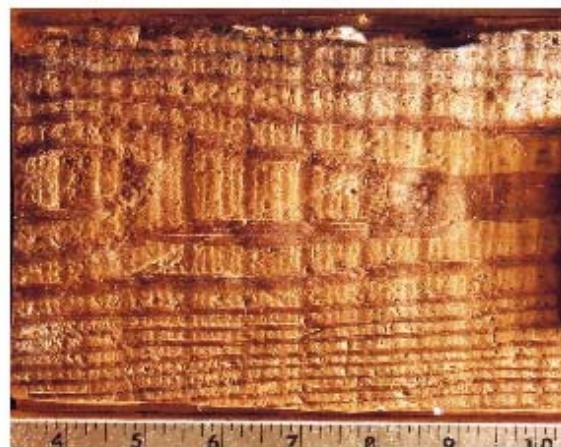
Figure 28: Planing details of the pattern-top sides of the boards. The photos are presented to scale, but slight variations may occur. Planing from left to right. Tongue edges up. The photos vary in lighting, condition of the boards and quality of the images.
